ARCHEOLOGICAL INVESTIGATIONS AND INTEGRITY ASSESSMENTS OF HISTORIC SITES AT FORT HOOD, TEXAS

United States Army Fort Hood Archeological Resource Management Series Research Report No. 41

Directorate of Public Works Environmental Management Office Fort Hood

Prewitt and Associates, Inc. Cultural Resources Services Austin, Texas

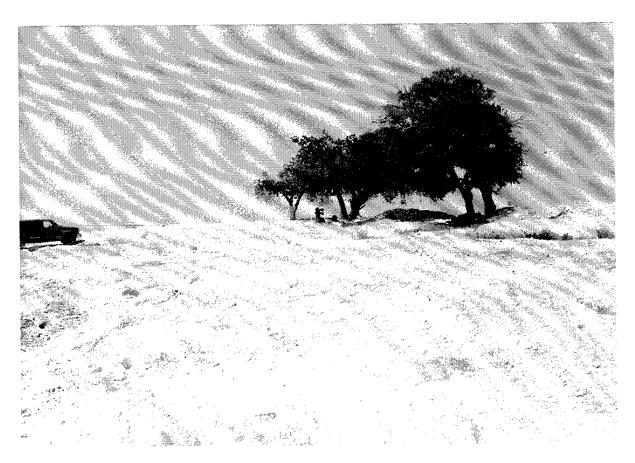
The initial field task involved re-locating each site based on records in the Fort Hood Archeological Resource Management files. The difficulty of this task varied, depending primarily on the amount of change between recordation and the revisit. Each of the sites had been last recorded/revisited between 1983 and 1990; thus, it had been between 6 and 13 years since they were last observed. Changes in vegetation and site setting due to natural and artificial (especially military) impacts in the intervening years were minimal in some cases and drastic in others. In some cases, site conditions were so severely altered that it was difficult to make the connection between new field observations and old site records. For example, site 41CV1303 had been previously recorded as a house site with several substantial features. When it was visited in 1996, the site had been destroyed and scraped down to limestone bedrock (Figure 3);

Figure 3. Site 41CV1303, a previous house site.

only sparse historic remnants and topography remained to indicate that a site had once been present. In all cases, no fieldwork was undertaken until site identity and location were confirmed.

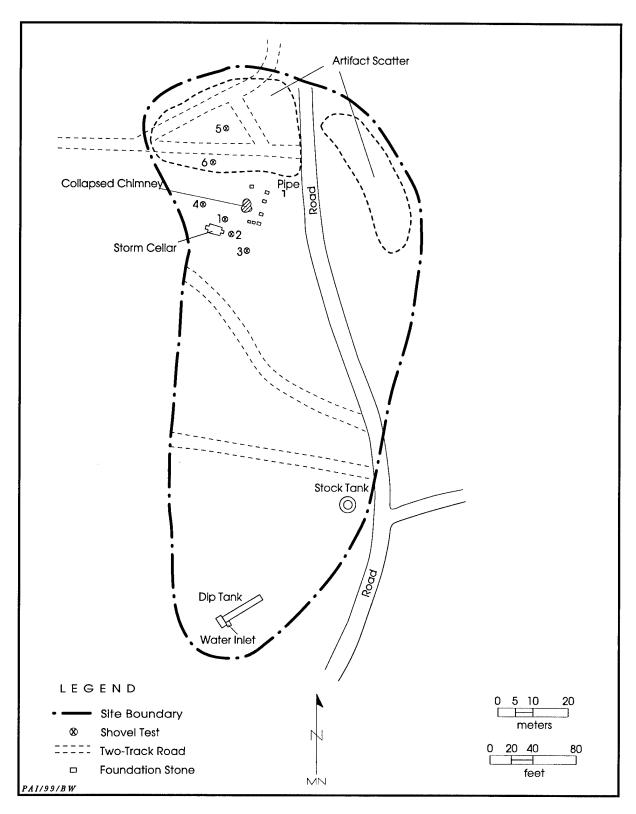
Figure 8. Site map of 41CV505.

Four shovel tests were excavated in the area between the storm cellar and the house foundation (Shovel Tests 1–4). Materials recovered included architectural artifacts such as cut nails (n=4), lead headed wire nails (n=2), brick fragments (n=5), wire (n=1), and window glass (n=2). Three sherds of bottle glass also were recovered. Recovery of artifacts in this area occurred generally between 0 and 13 cm.

Figure 9. Storm cellar at 41CV505. View is to the south, and the photograph scale is 1 m long.

This site has numerous surviving aboveground features and a high degree of horizontal spatial integrity. There is minimal evidence of disturbance, and subsurface deposits contain

associated artifacts. The archeological integrity of this site is high, and additional work could be informative.

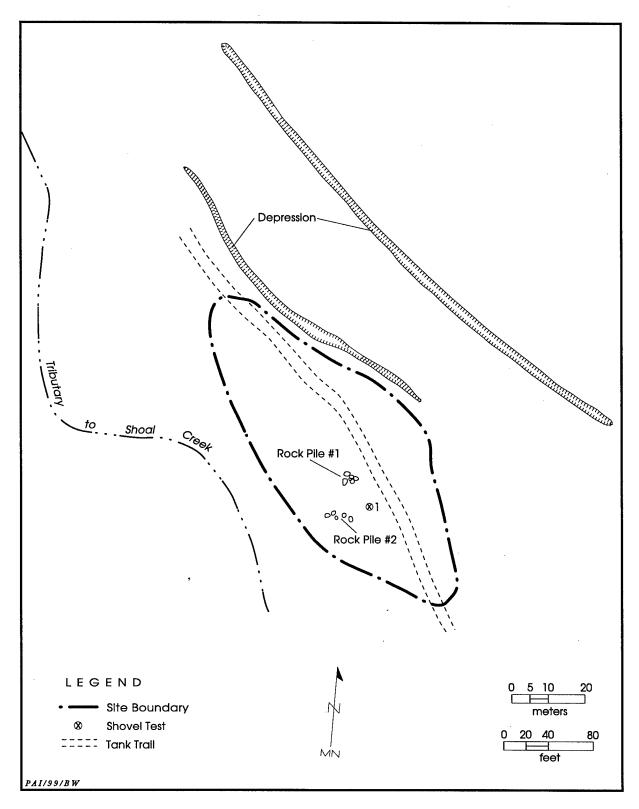
Figure 13. Site map of 41CV1149.

The only surface features recorded at 41CV1149 were the two limestone piles. The northernmost pile consists of a single layer of limestone rocks (ca. 4x4 m) with no indication of mounding; no pattern or alignment was observed. This pile is located at the southeastern end of a stand of trees at the base of a live oak tree. It is now overgrown with scrub brush and juniper. Some of the limestone rocks appear cut, and others seem to be natural. If this pile is related to structural remains of some sort, then it is extremely disturbed and has probably been impacted by vehicle traffic.

The second limestone pile is located in an open area ca. 12 m south of the first pile. This pile is a low, east-west linear mound, ca. 7 m long by 2.5 m wide. It consists of soil, grass, leaf litter,

Figure 14. General site area at 41CV1149; view is southeast.

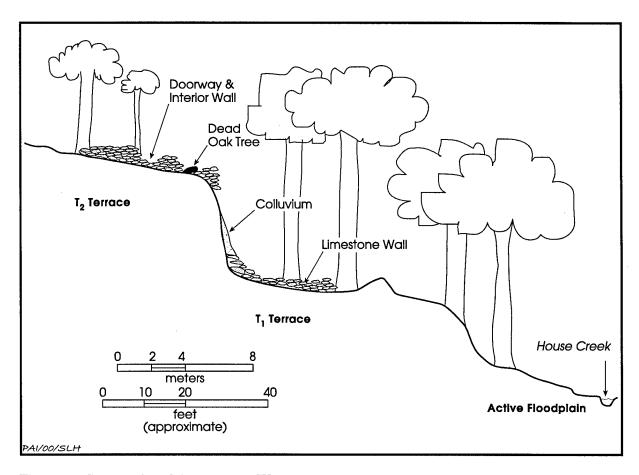
One minor surface feature at 41CV1223 was recorded previously as a stone wall with a rubble pile. It is now ca. 3 m in diameter and includes various sizes of limestone rocks. Most are of medium cobble size (ca. 10 cm), and a few specimens show alteration by fire—particularly discoloration and angular fragmentation. On the east side of the pile lie several tabular, medium-sized limestone rocks. No obvious patterning exists. This feature appears to be a push pile of

Figure 15. Cross section of site area at 41CV1223.

debris that was subsequently burned.
